Ukrainian BlackJack APT Attack on Moscow OT Infrastructure (Fuxnet)

Radiflow Threat Research Team Analysis
April 2024

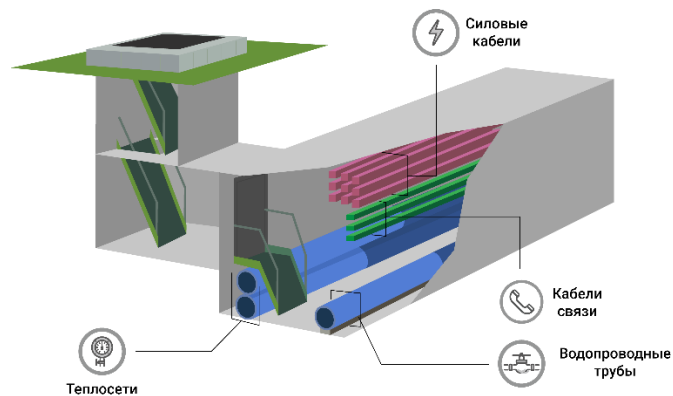
“[AO Moscollector](#)” is an enterprise that maintains the Moscow municipal infrastructure hosting water and heat supply pipes, power lines and communication cables, and other necessary infrastructure. This reinforced concrete structure is called “Communication Collector” (Коммуникационный коллектор) and Moscollector manages more than 800 km of these.

OT Communication Collector (From <http://moscollector.ru>)

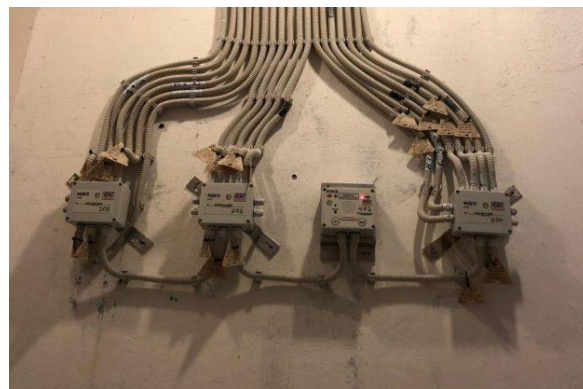
From screenshots released by hackers and via a quick Google search, one can find that [AO SBK](#) supplied to “Moscollector” the physical equipment and software for safety and security monitoring of the collectors’ infrastructure. “SBK” stands for “System of Collectors’ Security/Safety” (система безопасности коллекторов).

Monitoring Infrastructure (From <http://ao-sbk.ru>)

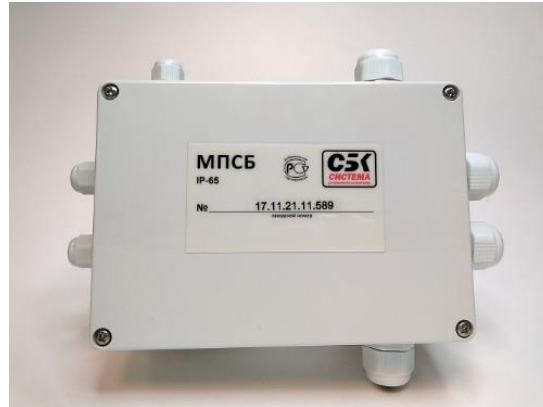
- MPSB (МПСБ - Модуль передачи данных системы безопасности) – a piece of hardware for data exchange with “high-level” monitoring servers using TCP/IP or GPRS and at the “sensor-level” using RS-232, RS-485, CANbus, and Ethernet. Also, it can be integrated in other systems using the OPC UA protocol.

Data Exchange Module (From <http://ao-sbk.ru>)

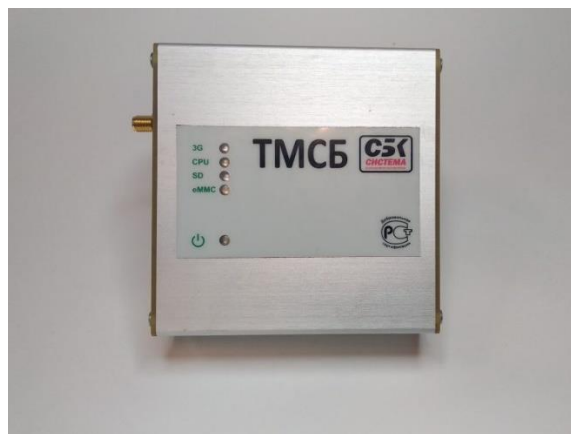
- TMSB (ТМСБ- Телеметрический модуль системы безопасности) – an IOT gateway (like MPSB) for telemetric data exchange with “high-level” monitoring servers using 3G/4G networks.

Telemetric Data Exchange Module (From <http://ao-sbk.ru>)

From data leaked by the Blackjack hacker group, these TMSB modules were hacked by using default credentials: user:sbk, password:tempPWD .

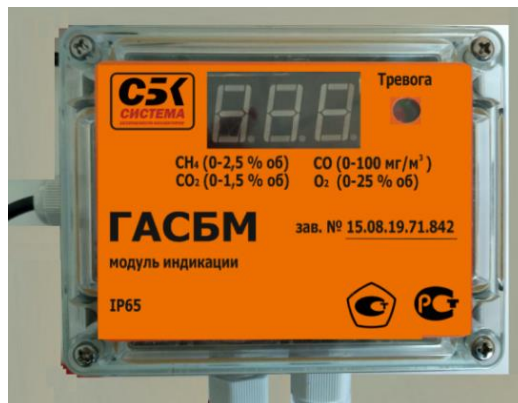
- Sensors for gas (oxygen, methane, etc.) level analysis and measurement (ГАСБМ - сертифицированный газоанализатор собственной разработки).

Gas Analyzer Module (From <http://ao-sbk.ru>)

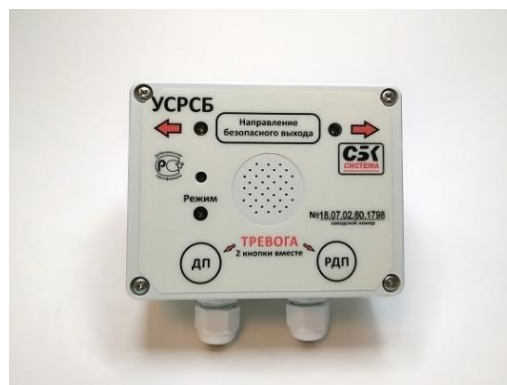
- Voice communication device for emergency voice communications, alarms, and two-way internal comms (УСРСБ - Устройство речевой связи). It includes native CANbus connectivity and can be also connected to existing on-site IP Telephony.

Voice Communication Module (From <http://ao-sbk.ru>)

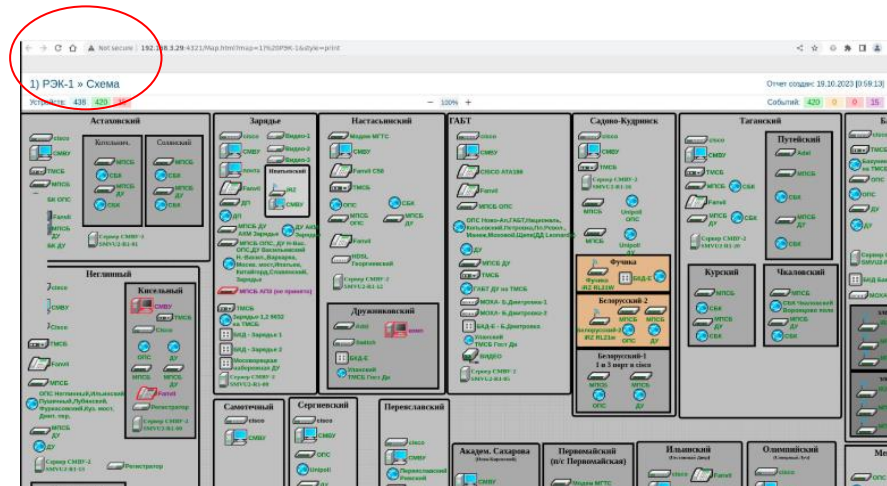
The attack carried by BlackJack can be categorized as a full-blown CNA campaign. The attackers have the all data they need data. The screenshot below displays the network topology and asset type for REC-1. In Russian, "РЭК" stands for "Район эксплуатации коллекторов" which can be translated as "Collectors' Operation Area". We also can observe that the number of assets is around 870.

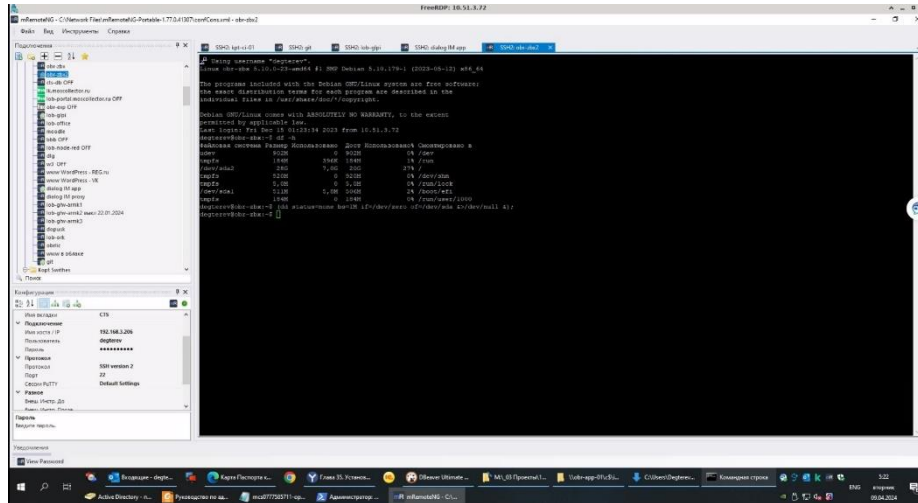
The hackers managed to successfully delete the data on multiple servers, user workstations, and backups, amounting to 30TB of data loss, according to the screenshots below:

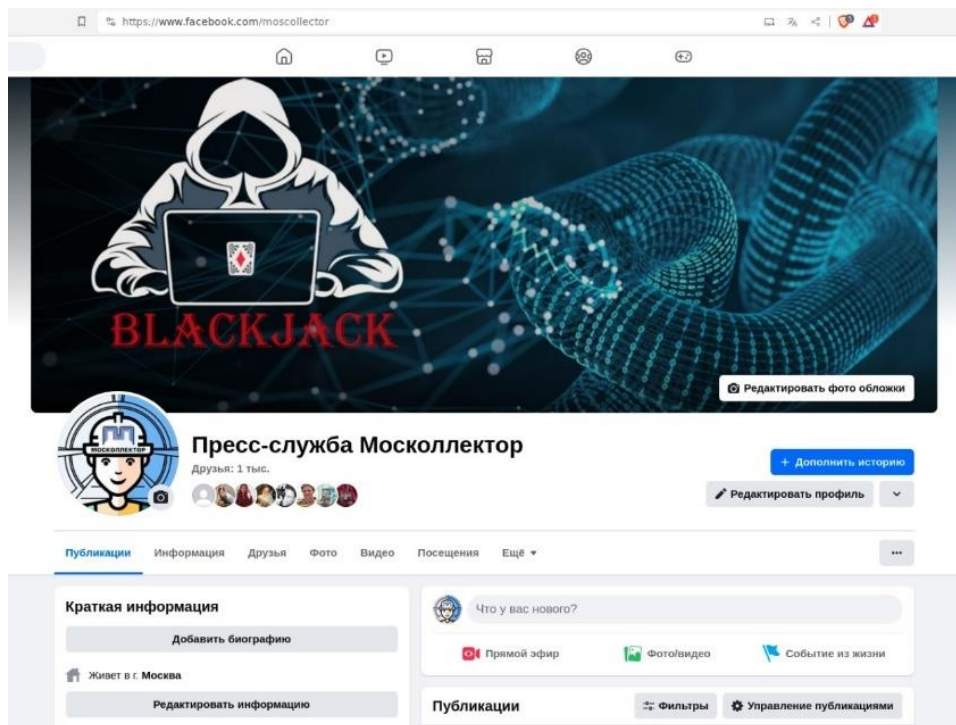
The hackers defaced the Facebook page and website of “Moscollector” (according to the screenshots below), and took over DNS and email services.
